Rebuilding a launching trolley

By Jon Davies, Shrimper 19 *Merriwinds* (847) (October 2024)

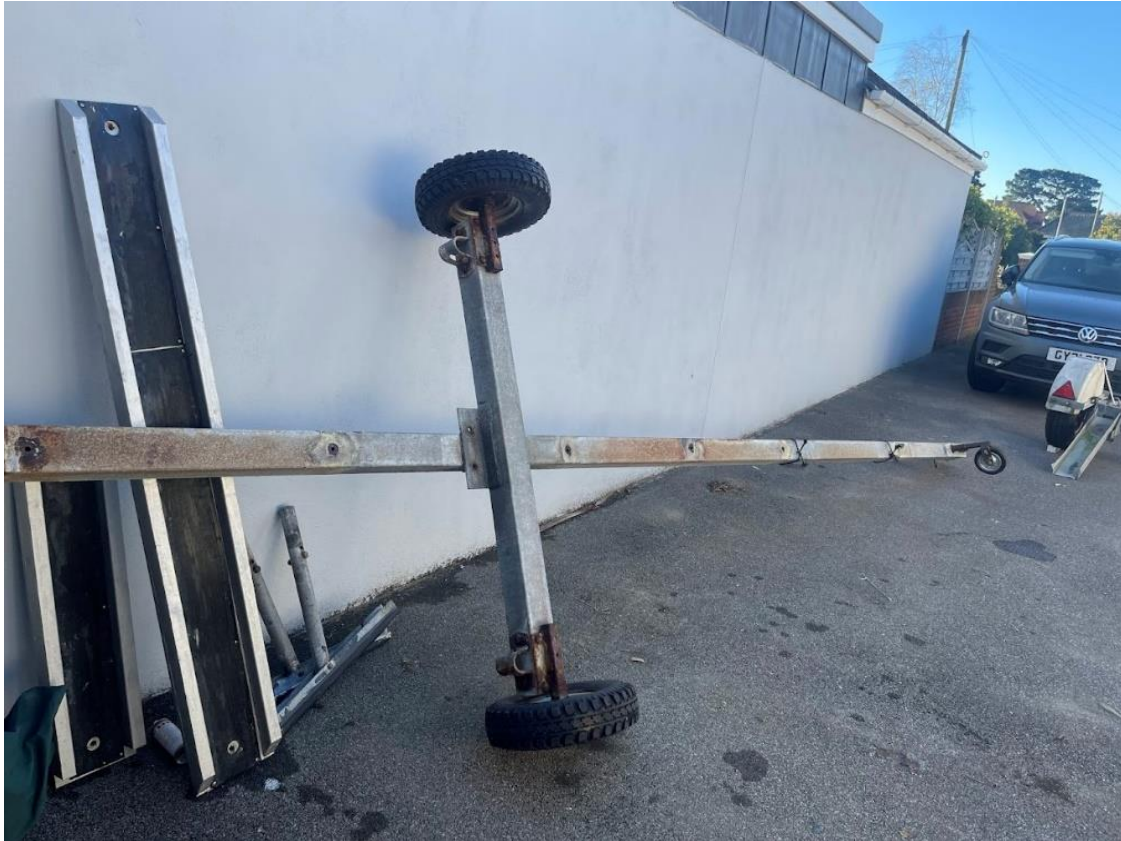
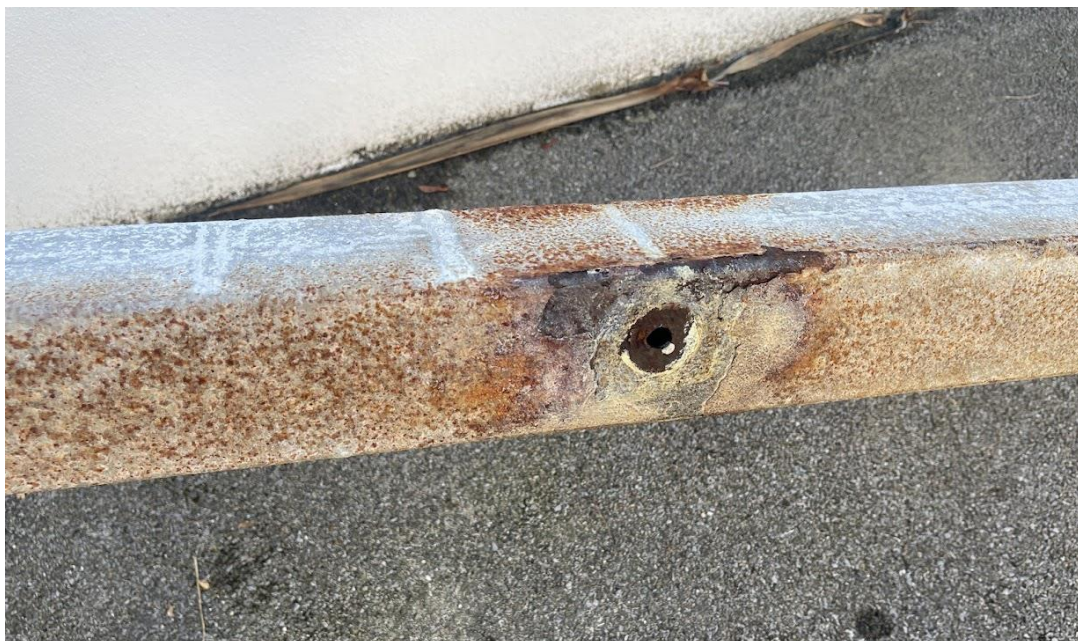
Our Snipe combi trailer is about 12 years old, and although properly maintained, has had a lot of use with the launching trolley going into the water several times a year. It has always been carefully rinsed off with fresh water after every immersion, and until recently seemed to be in very good condition. However, after its latest dip I was dismayed to discover that, although everything else was fine, the galvanising on the spine was quickly deteriorating and it was becoming very rusty. It looked as if the original galvanising had not been very well done. There is also no way of examining the interior where the corrosion could be far worse. If the metal was on a garden gate, you could probably rub it back to bare metal, treat it and it would be good for several more years. On a trolley that carries the full weight of a Shrimper over long distances, knowing the main part of it is badly rusting (and which would get worse every time it is put in the water) is a big problem.

Photos 1 and 2: The galvanising was flaking off. (The hubs on the axle look rusty but are solid steel blocks).

Those trailers are not made any more, and finding an exactly compatible trolley in good condition (and at a sensible price not too far away) didn't seem likely. However, eventually I realised that, apart from some holes and a simple plate welded on, the spine is just a long piece of 90mm x 90mm x 3mm galvanised box section. Everything can be unbolted from it, so making a new one is possible.

I ordered the steel from Brundle metals of Southampton on a Sunday evening and they delivered it, cut to the correct size of 5356 mm the following Tuesday morning! I then had to measure the original tube and carefully mark the position of everything on the new metal. It was then on to drilling lots of holes which was best done using a pillar drill outside. The hardest job was cutting the large 52mm holes for the jockey wheel. That was just accomplished by using the drill's slowest speed, a new tank cutter and lots of patience. I then cut off the jockey wheel bracket (just a piece of steel plate) from the old trailer and, after cleaning it up, welded it into place.

The next problem was getting the large piece of metal galvanised. Wessex galvanisers of Eastleigh are one of the few places that can do that sort of work. They said they couldn't collect and deliver to a residential address, so I had to carry the 65kg tube strapped to the road trailer to Eastleigh; not a pleasant journey with the empty road trailer ramps rattling behind. The galvanisers were also very efficient, and four days later after another noisy drive to Eastleigh, I had my brand-new shiny trolley spine. Reassembly was easy, everything fitted and I now have a trolley that should last at least another 12 years as all the other fittings are easy to replace if the main spine is OK.

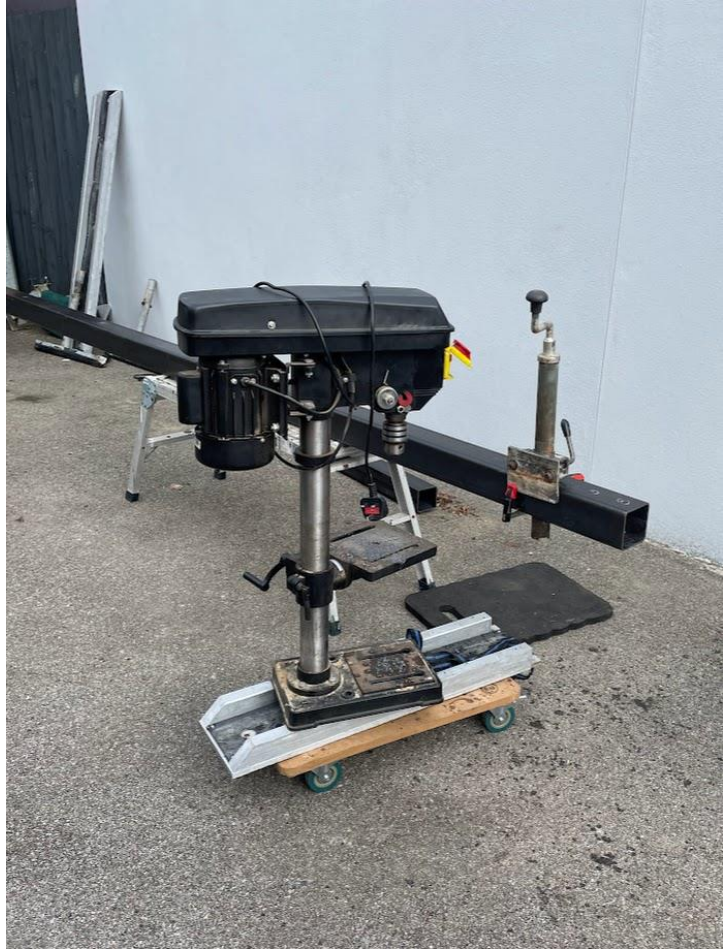
Photo 3: Drilling the holes needed the precision of the pillar drill. The jockey wheel plate has been clamped into position to make sure everything fits before welding.
Picture 4: Everything reassembled and looking solid again, the shiny metal will soon go dull and match everything else.
